# MASTER PLAN

## A.B. Sawyer Park

Louisville, KY

October 2012

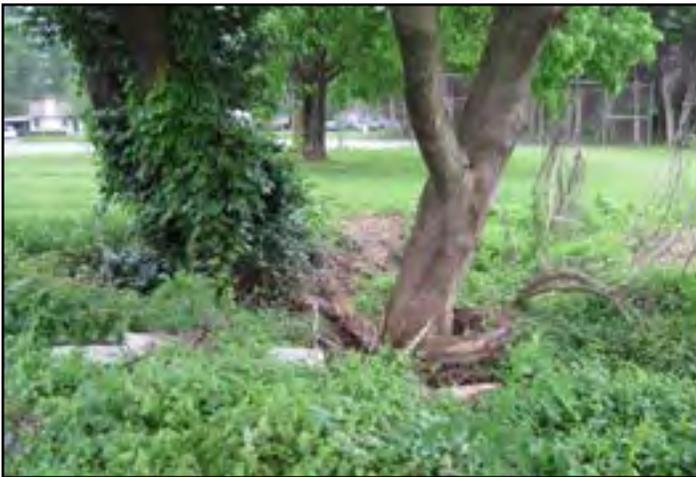
*Sinkhole located near existing tennis court location*

The open water feature is located in the northwestern section of woods on-site. It originates from an intermittent stream off-site and becomes an open water feature with depths from two to six feet. Trees are growing in the shallow portion of this feature. The deeper portion of this feature is near a presumed sinkhole.

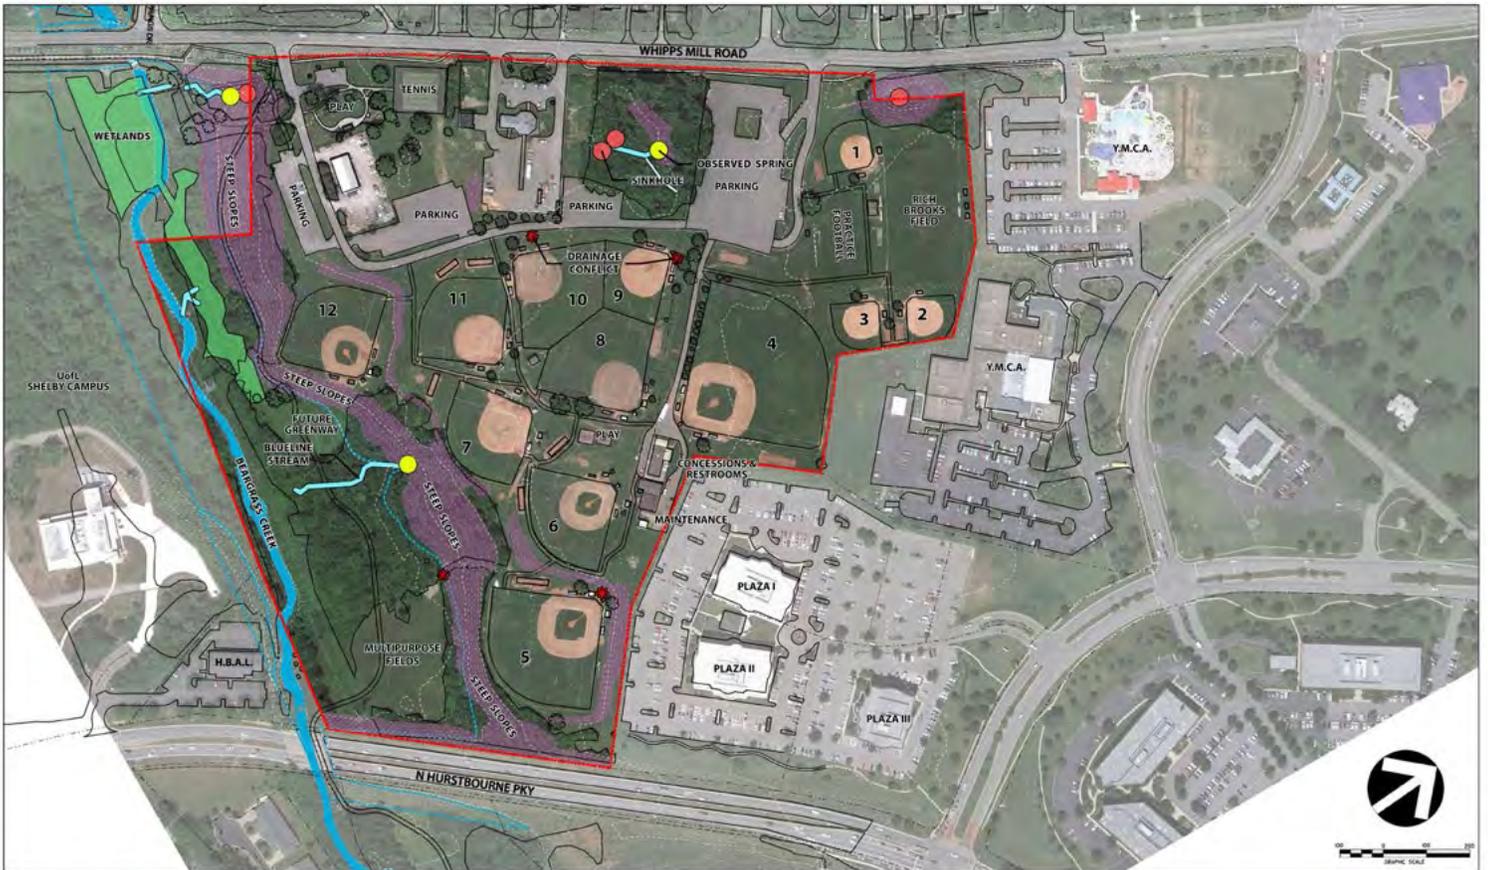
**A.B. SAWYER PARK MASTER PLAN**  
Louisville, Kentucky  
**EXISTING CONDITIONS**  
June 29, 2011

PERENNIAL STREAM		SEEP/SPRING
	INTERMITTENT STREAM		SINKHOLE
	WETLANDS		DRAINAGE CONFLICT

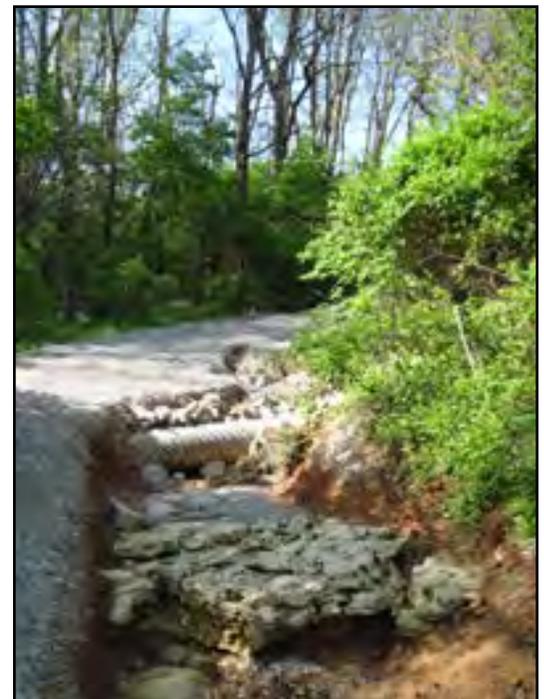
*Drainage issues along access road to practice fields*

The most significant drainage problems are occurring along the wooded slope behind ball field 5 where storm water from offsite development to the north of the park, conveyed through an underground pipe, is discharged at a headwall near the top of the slope and has severely eroded the gravel access to the football practice area. Storm water best management practices that will dissipate the velocity of this discharge during peak rain events will be needed to eliminate this problem (see existing conditions map).

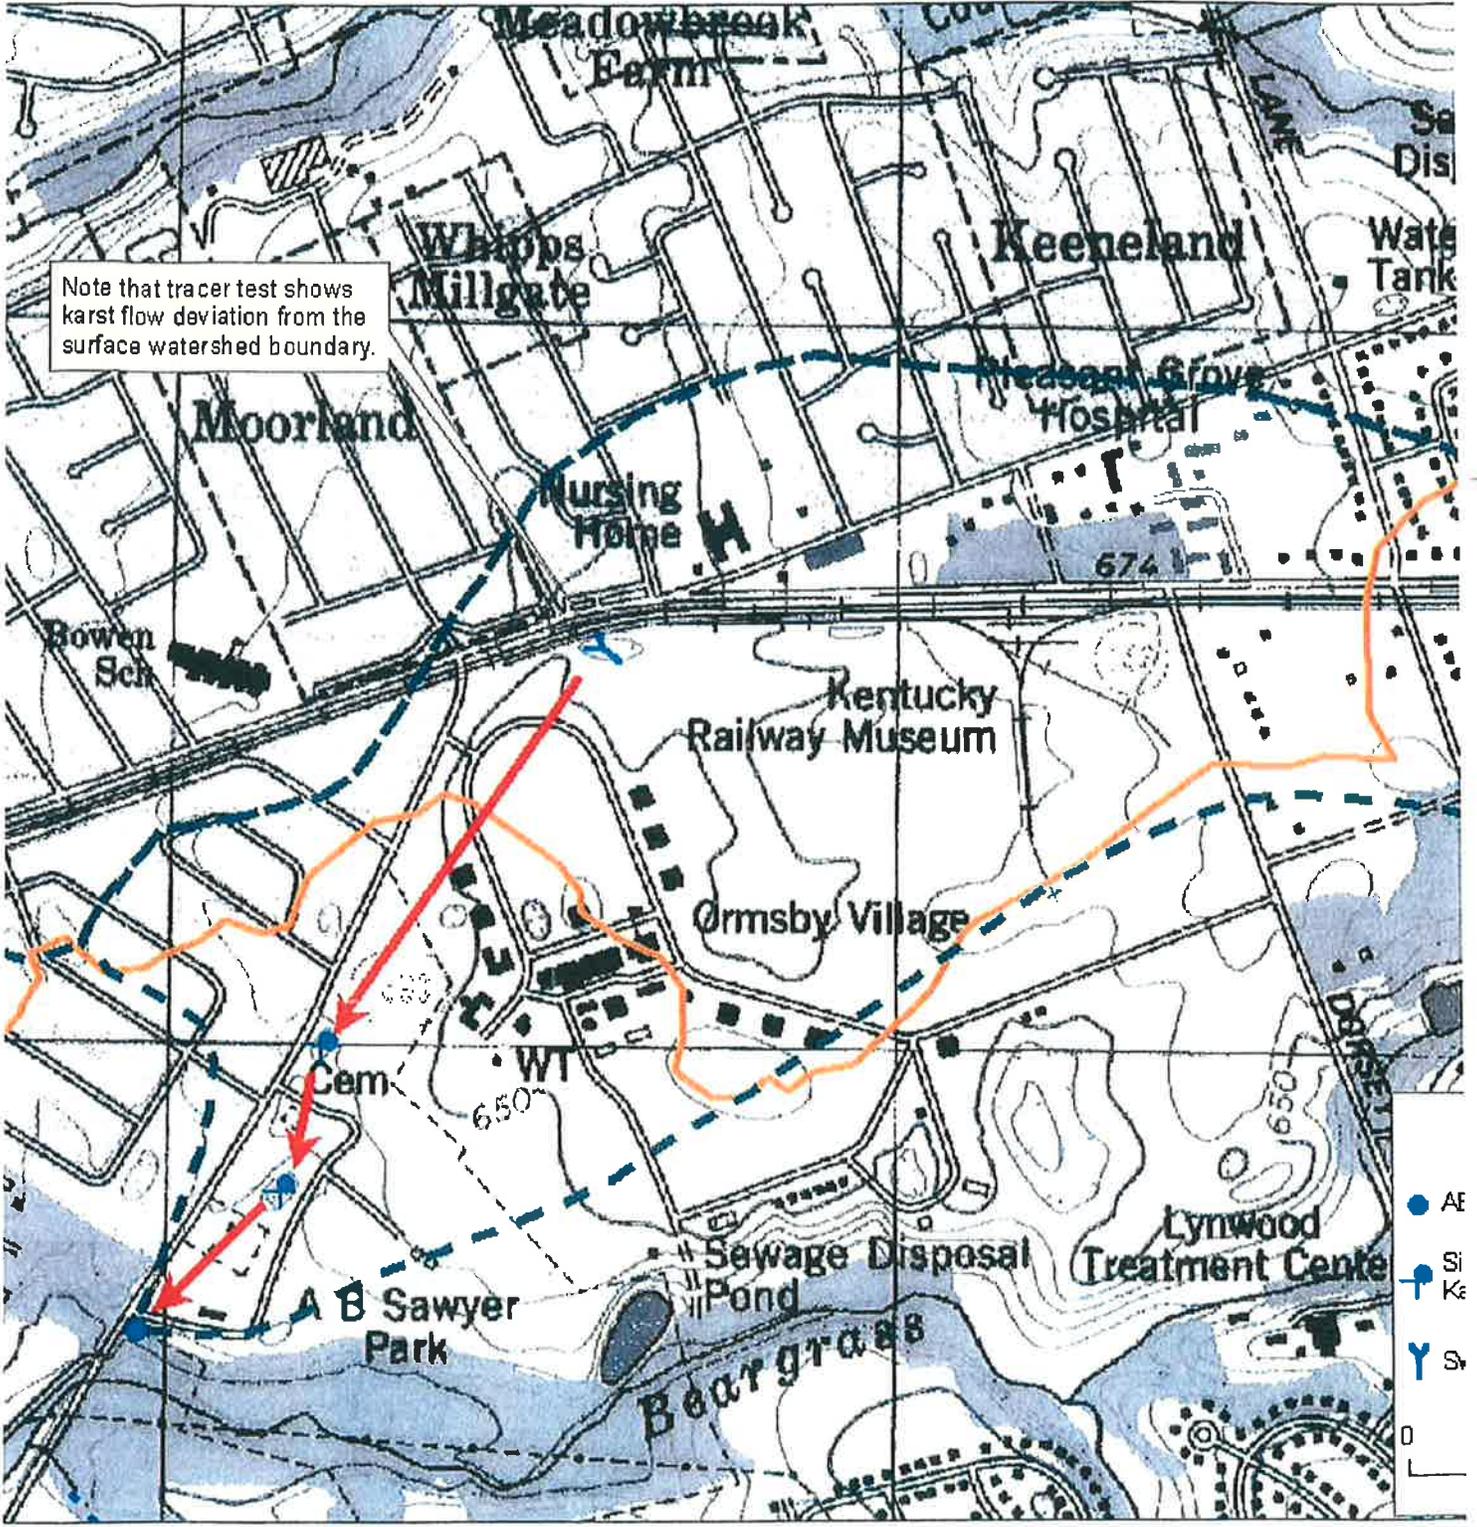
Note that tracer test shows karst flow deviation from the surface watershed boundary.

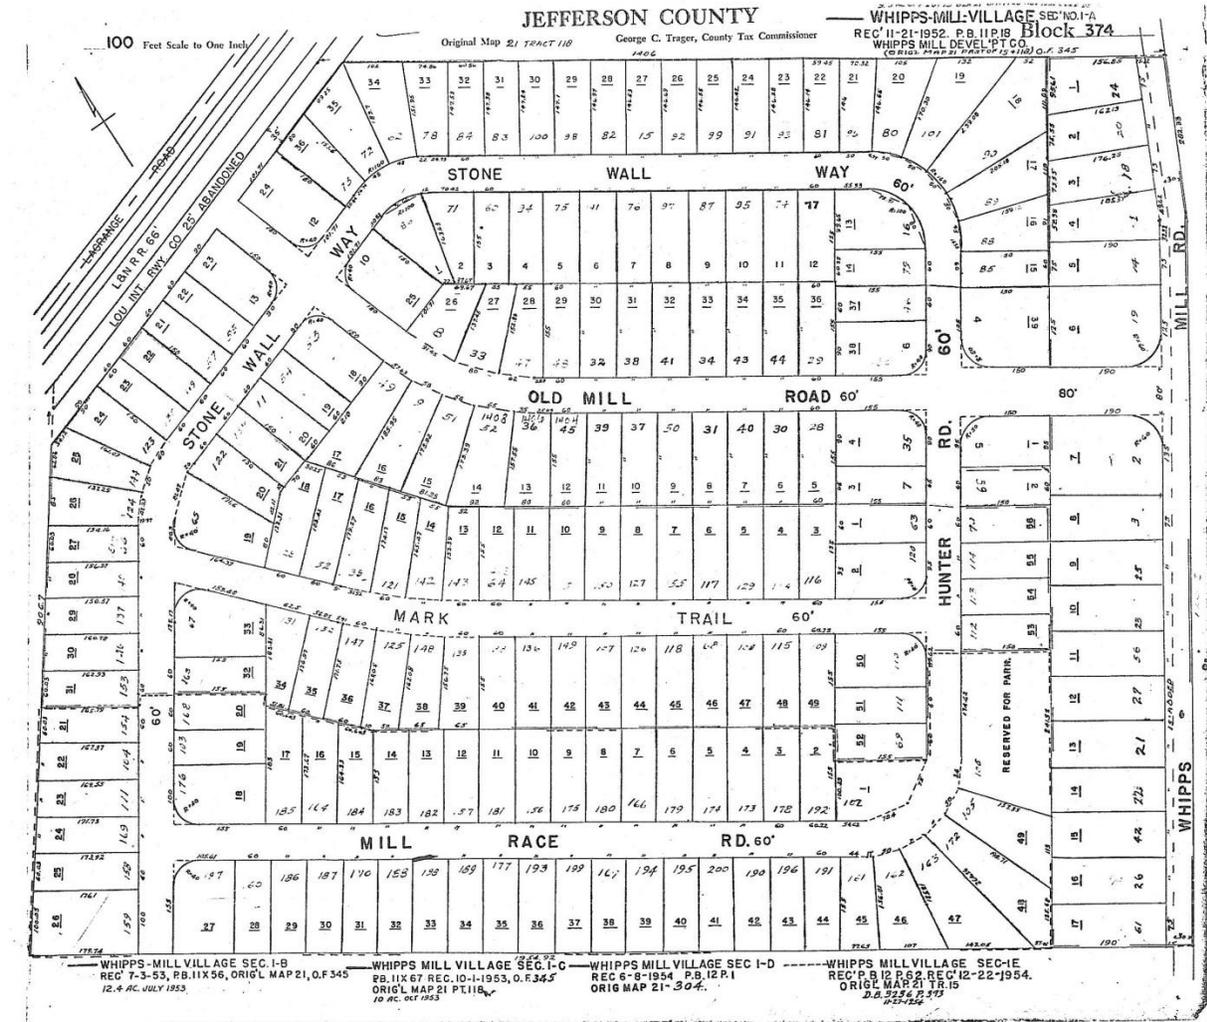
**Figure 55. Whipps Mill Village was planned 1953-1954 as a curvilinear subdivision and included Gunnison prefabricated homes manufactured by United States Steel Corp.**

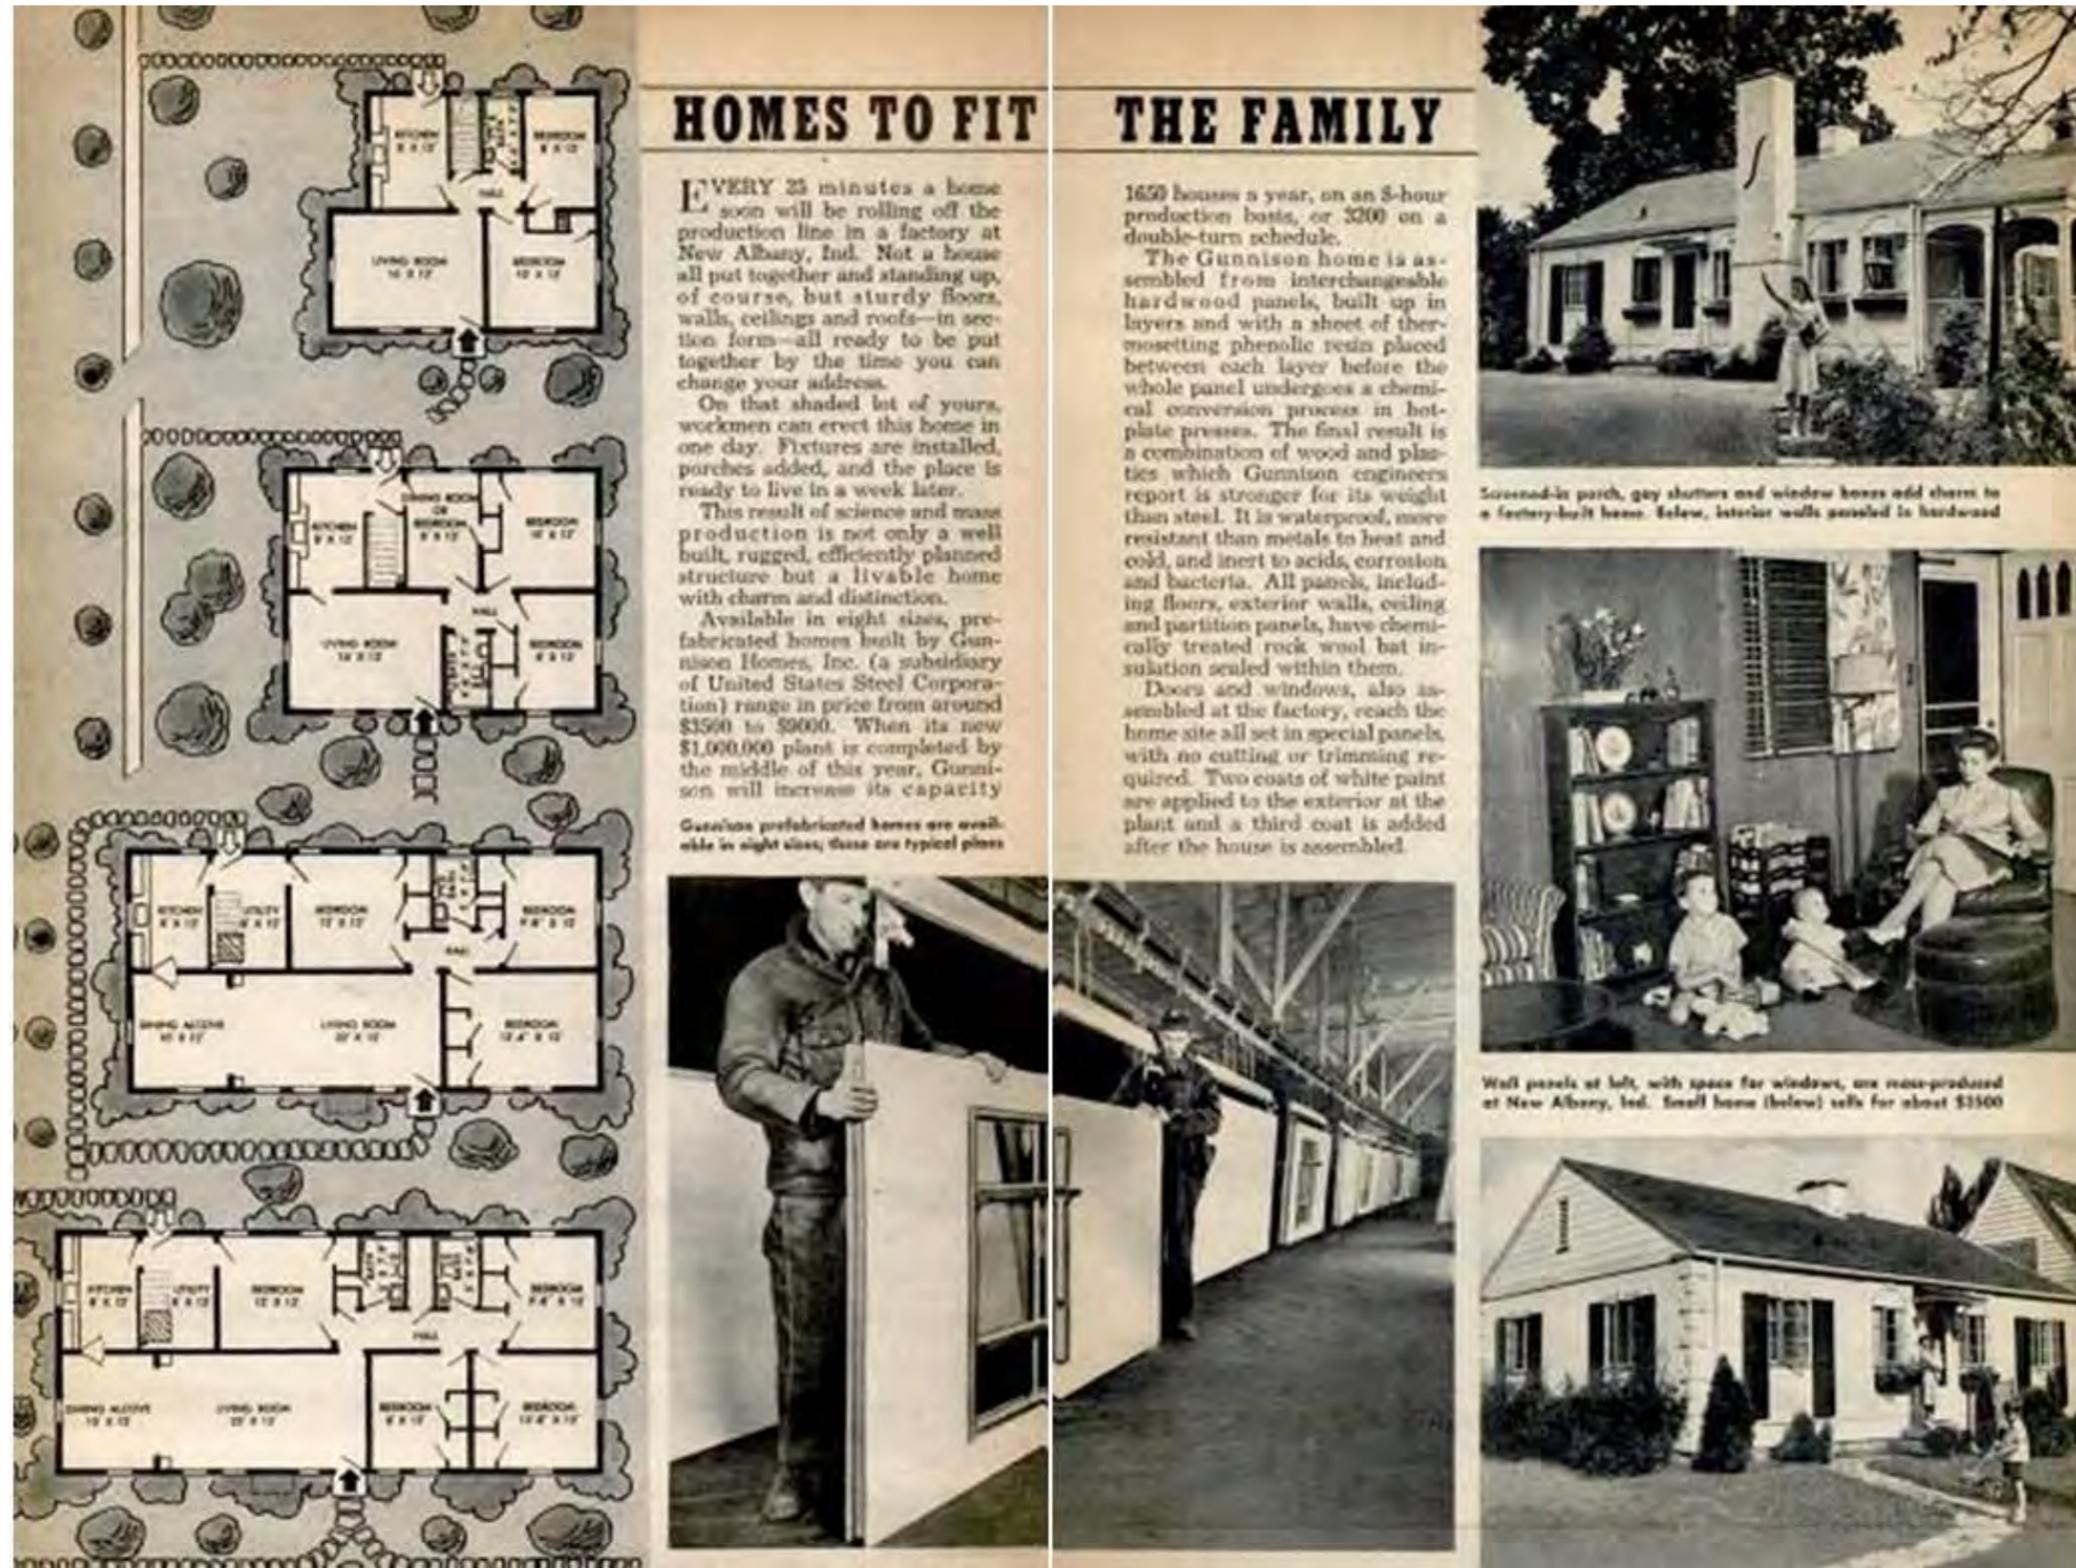
Figure 56. 1946 *Popular Mechanics* article on Gunnison Homes, showing the prefabrication process from planning, to production, to inhabiting the home.

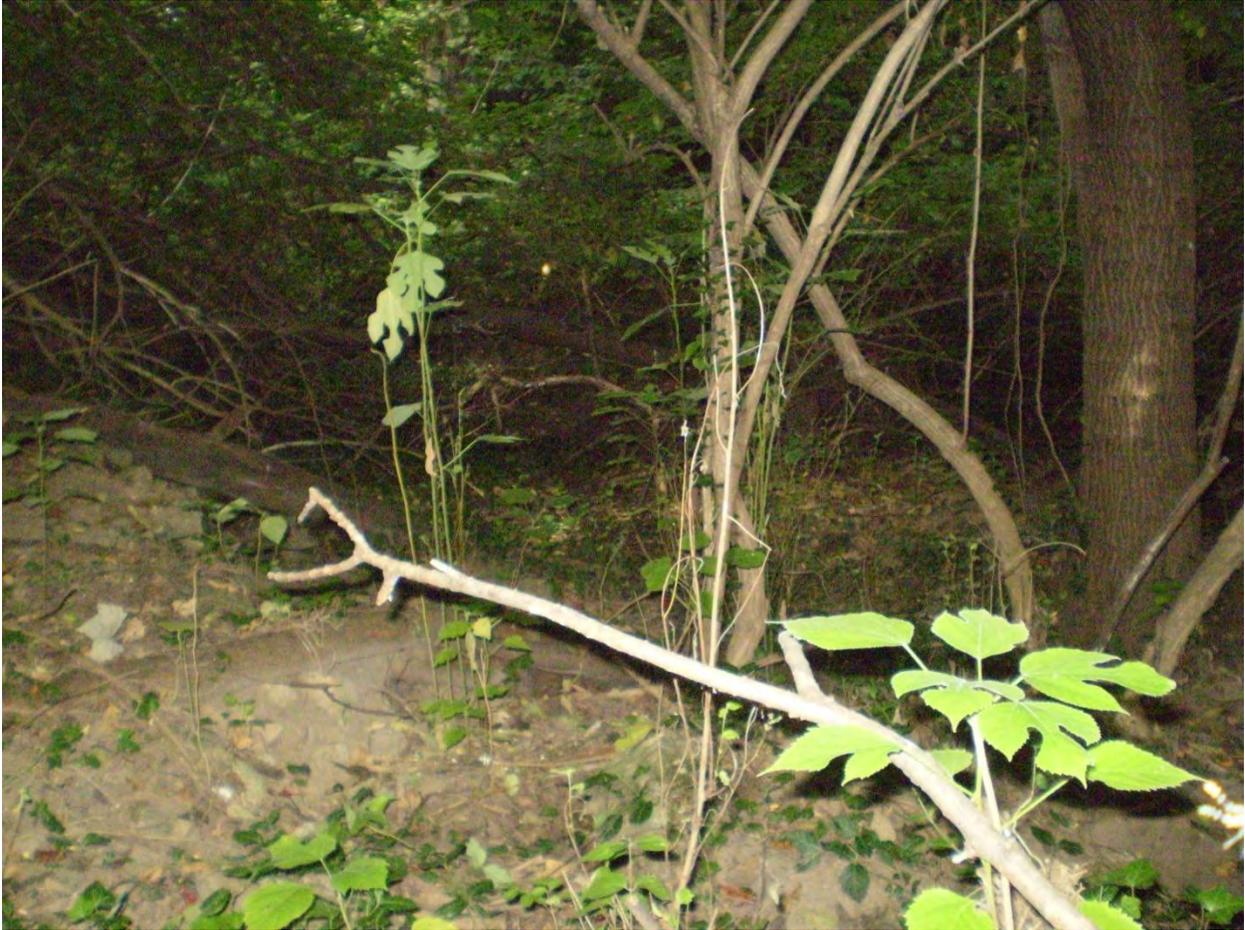
**Figure 73. General overview of house foundation and central depression. Southern wall foundation to left of photo, depression to right, facing northwest.**

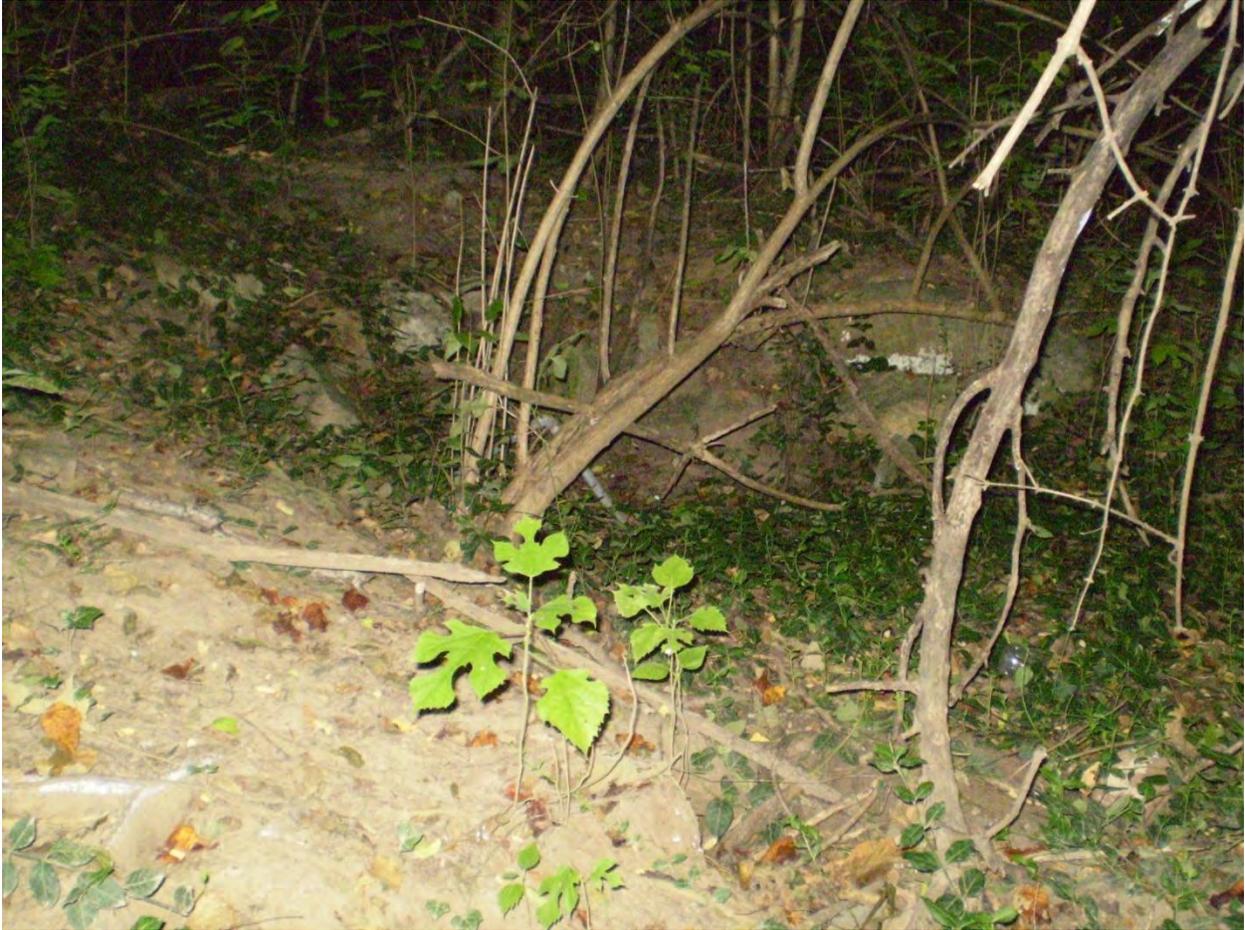
**Figure 74. Northeast corner of house foundation and depression.**

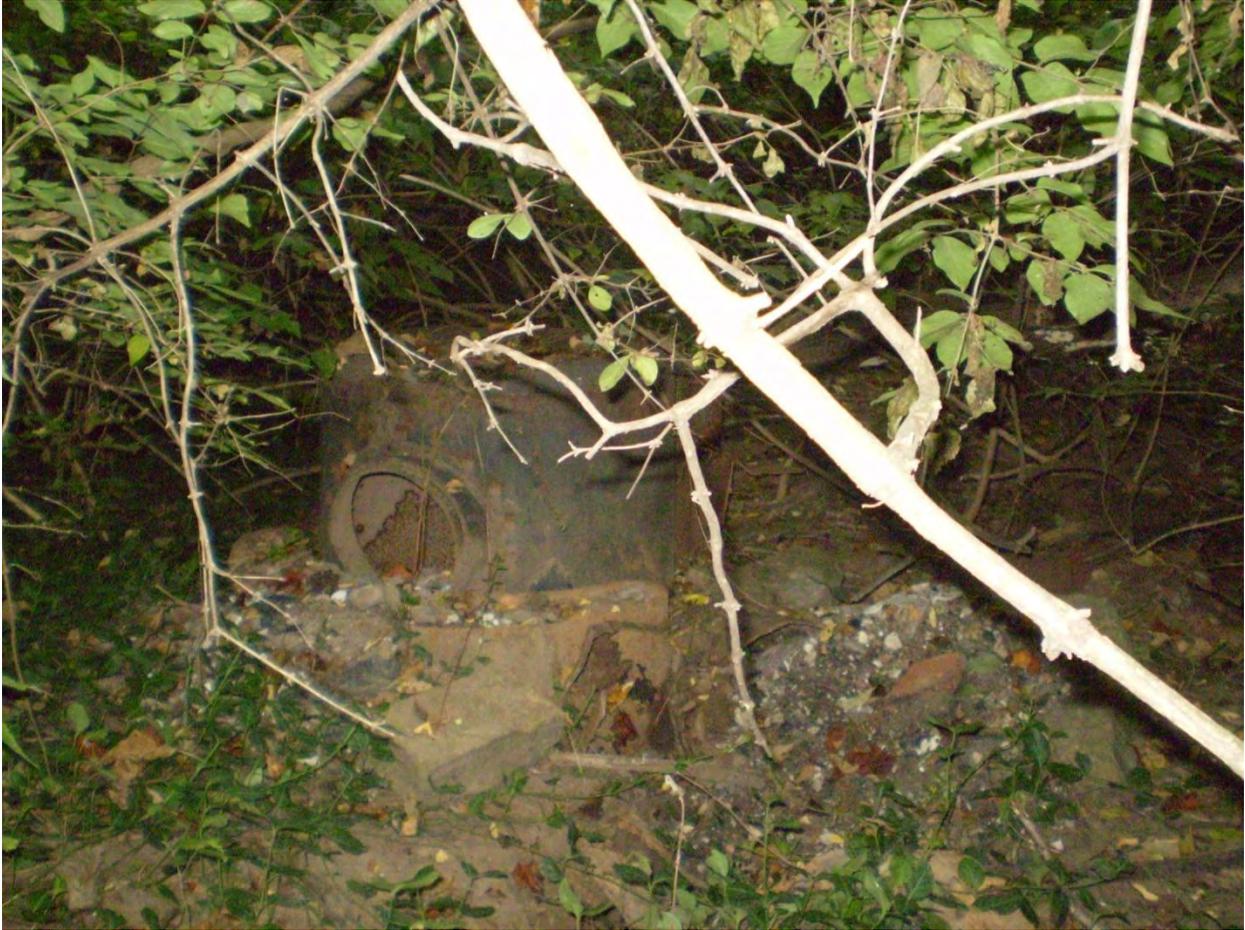
**Figure 75. Old furnace and construction material within central depression of house, facing east.**

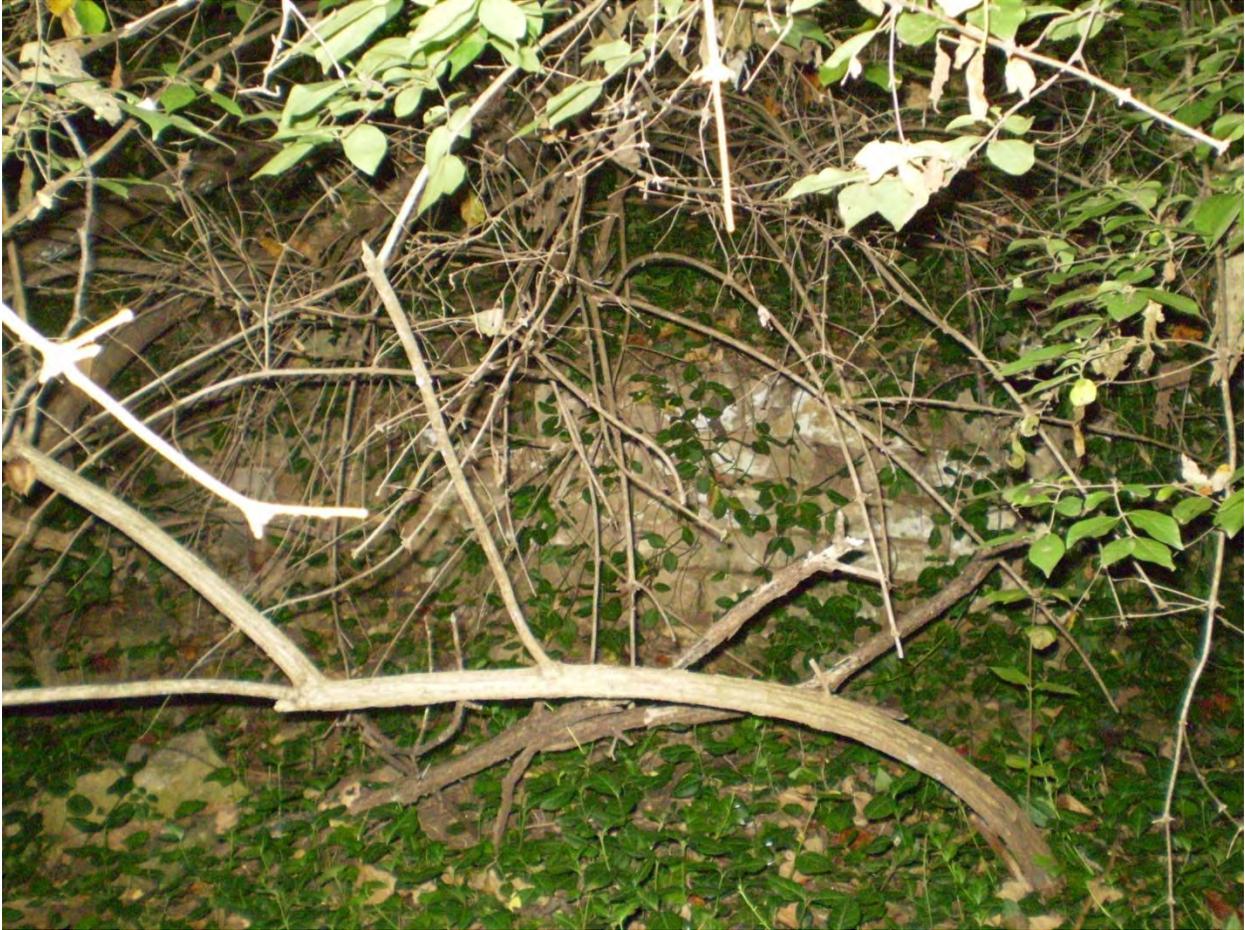
**Figure 76. Southern foundation wall of house from within central depression, facing south.**

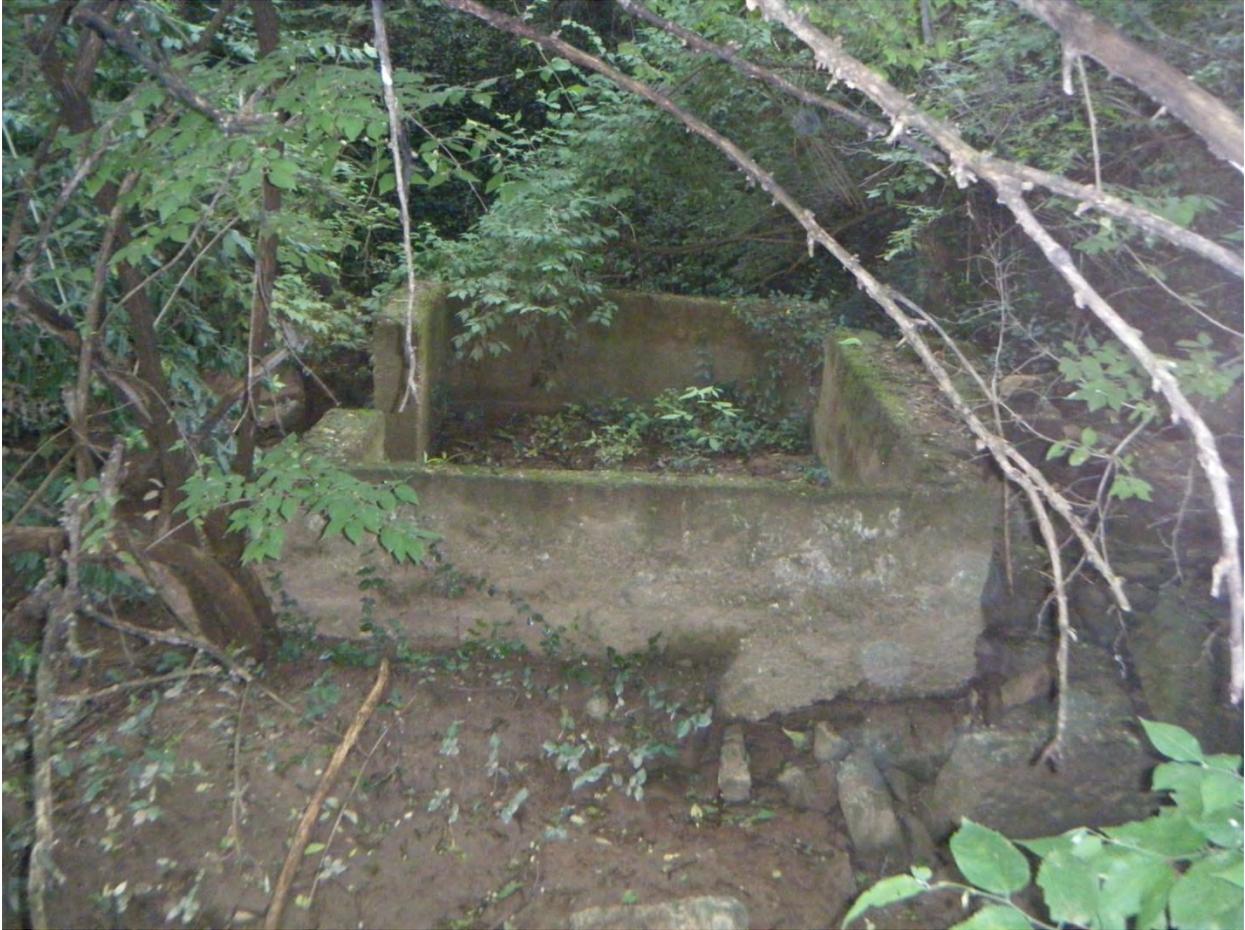
**Figure 79. Foundation at base of large sinkhole, facing northeast.**

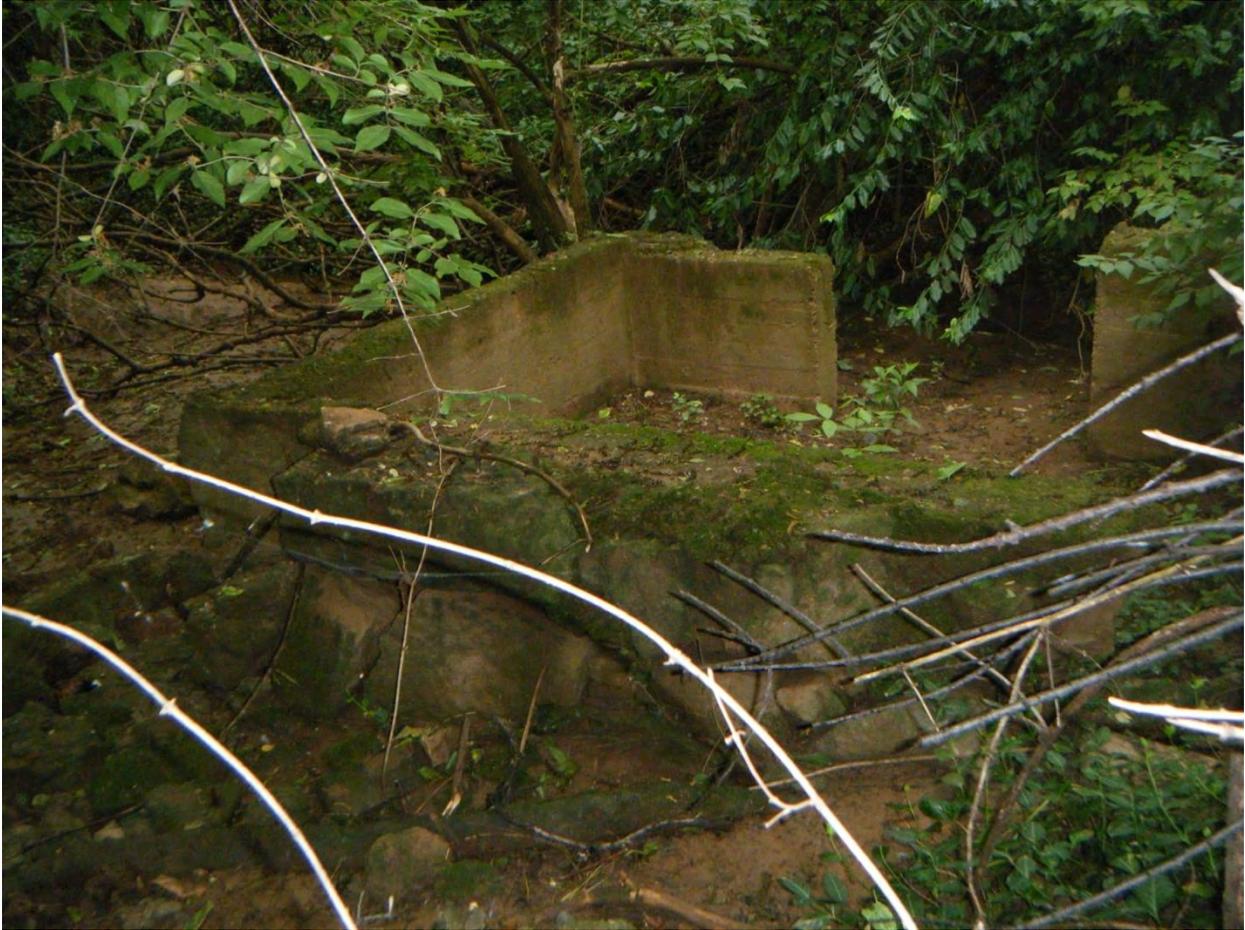
**Figure 80. Limestone and concrete foundation at base of large sinkhole next to spring, facing west.**

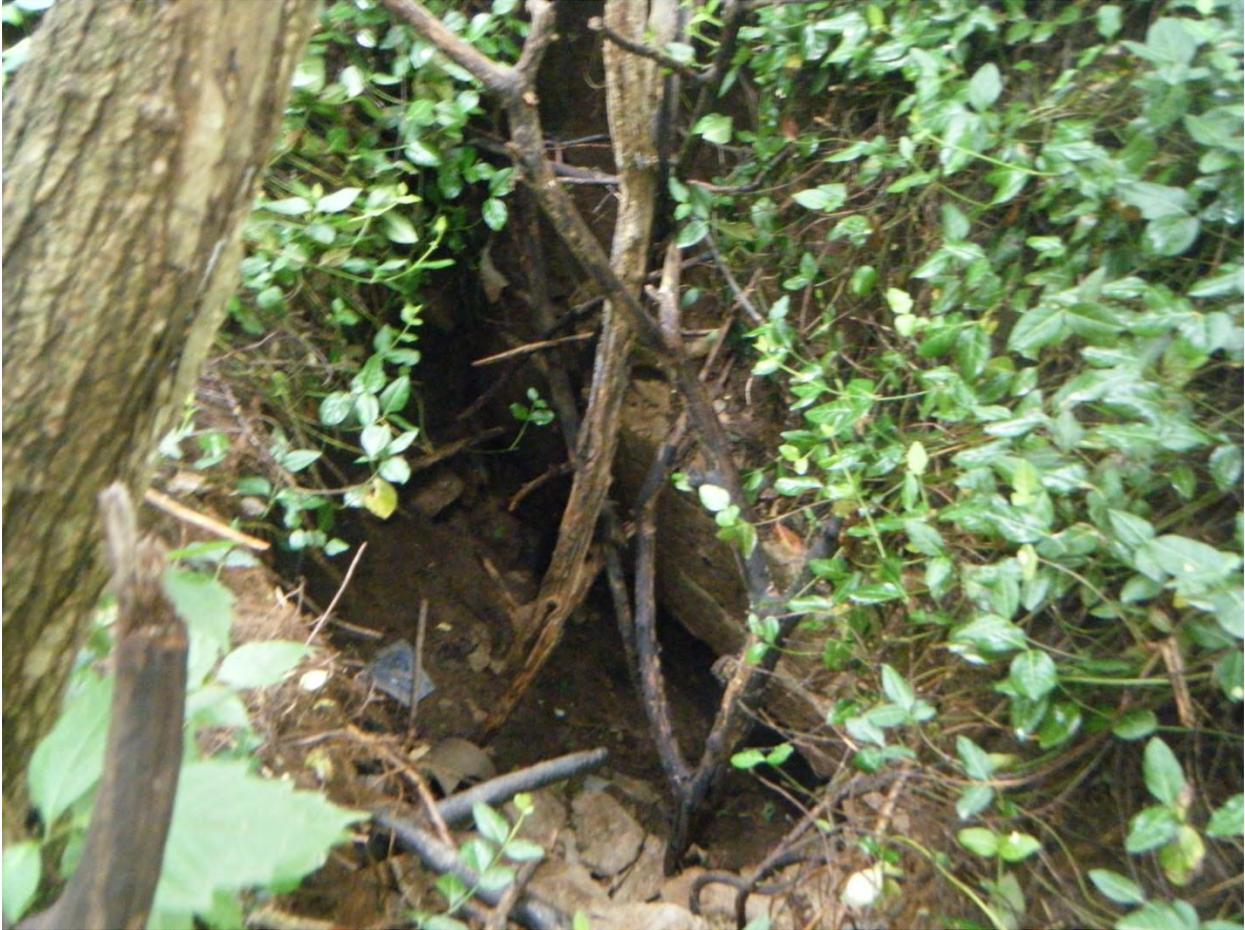
**Figure 81. Cave entrance at base of large sinkhole, facing west.**

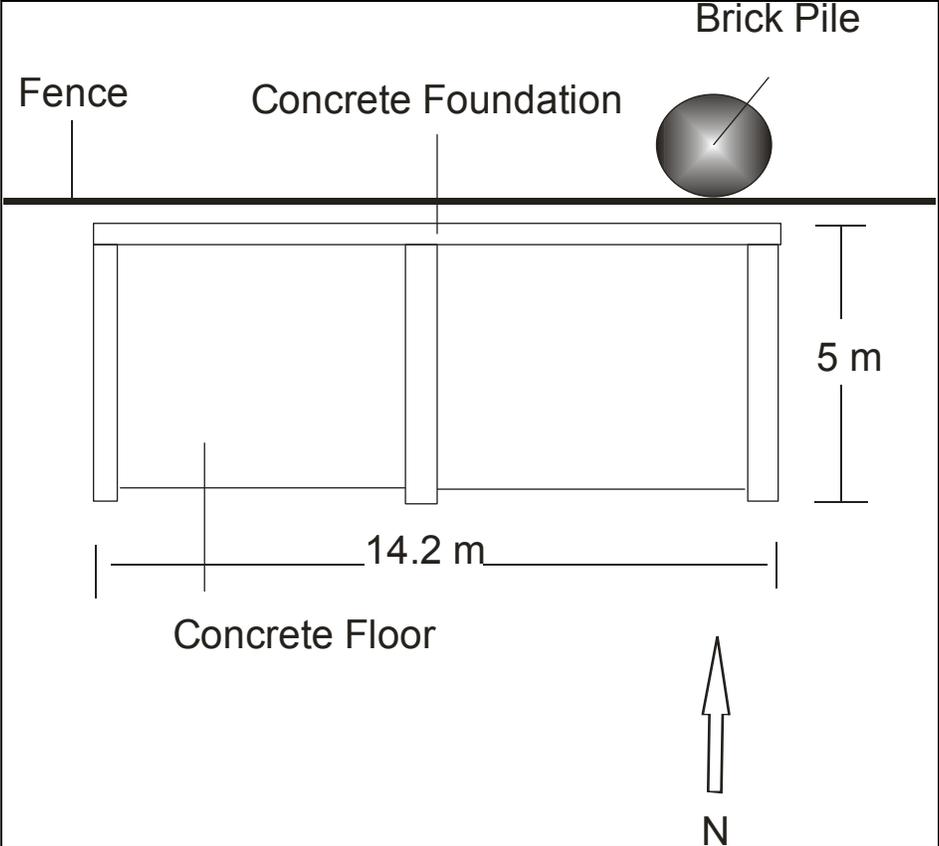
Figure 85. Plan of concrete foundation in woodlot along slope.

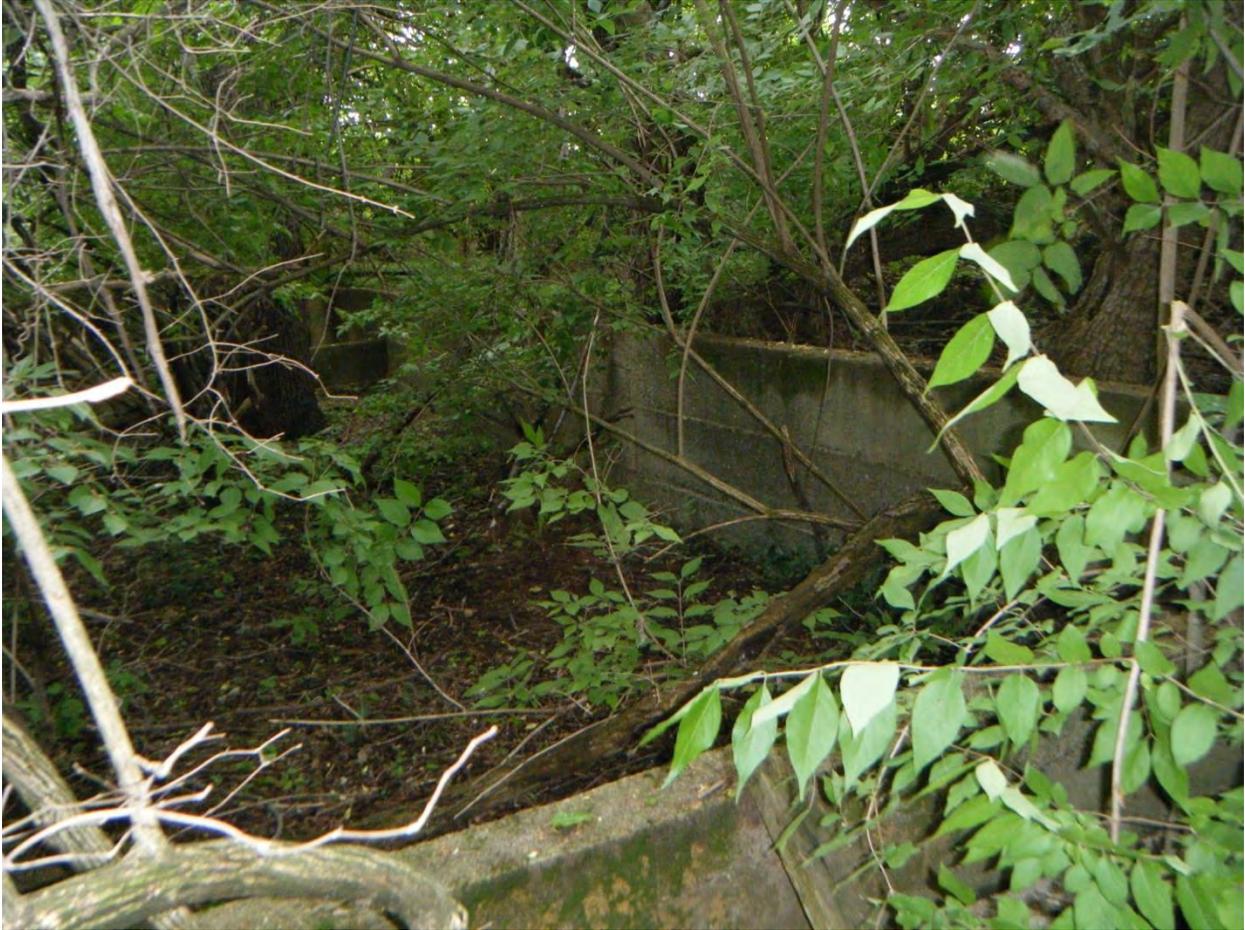
**Figure 88. Concrete foundation of structure located in sloped and wooded area south of ball fields.**

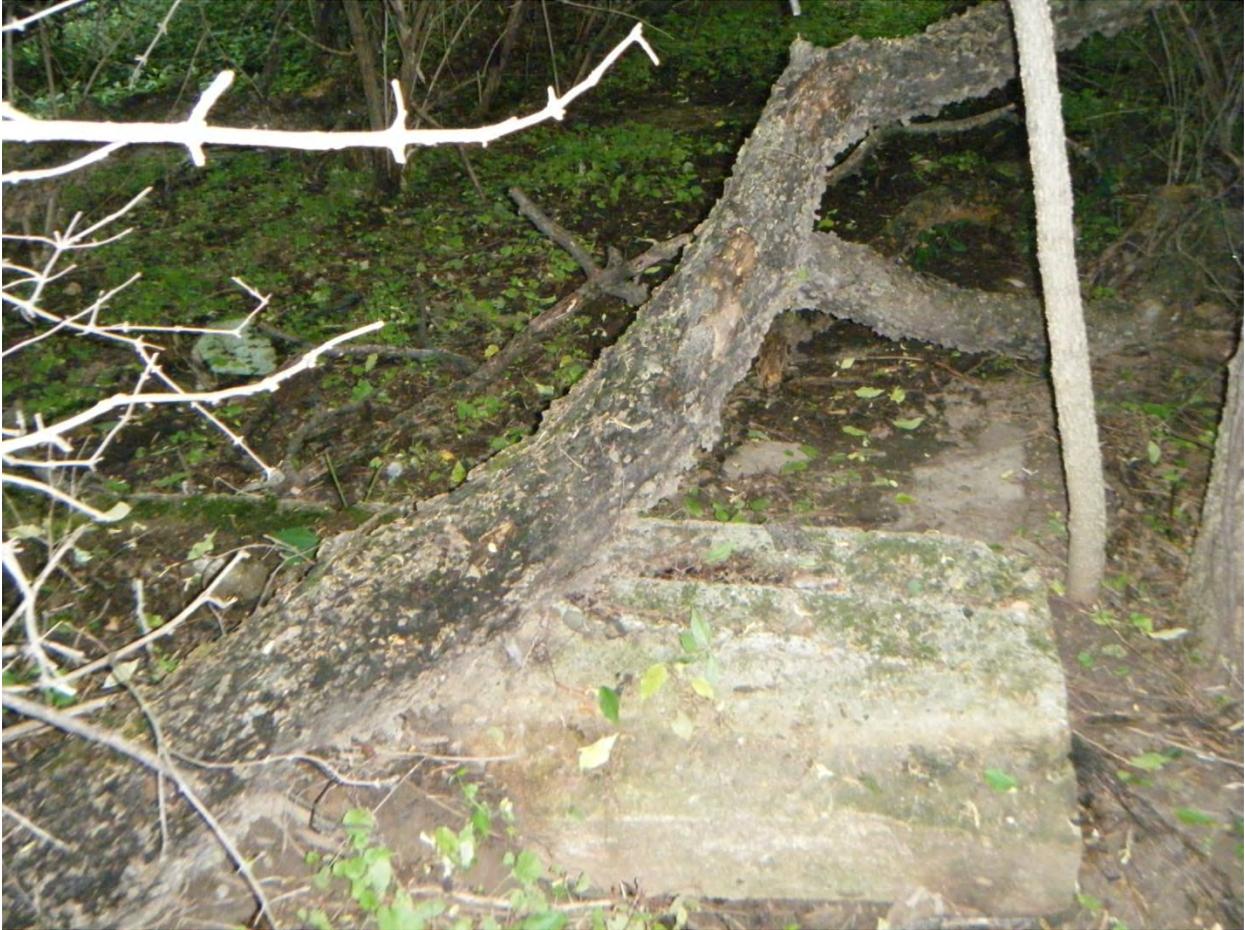
**Figure 89. Poured concrete floor and foundation, facing east.**

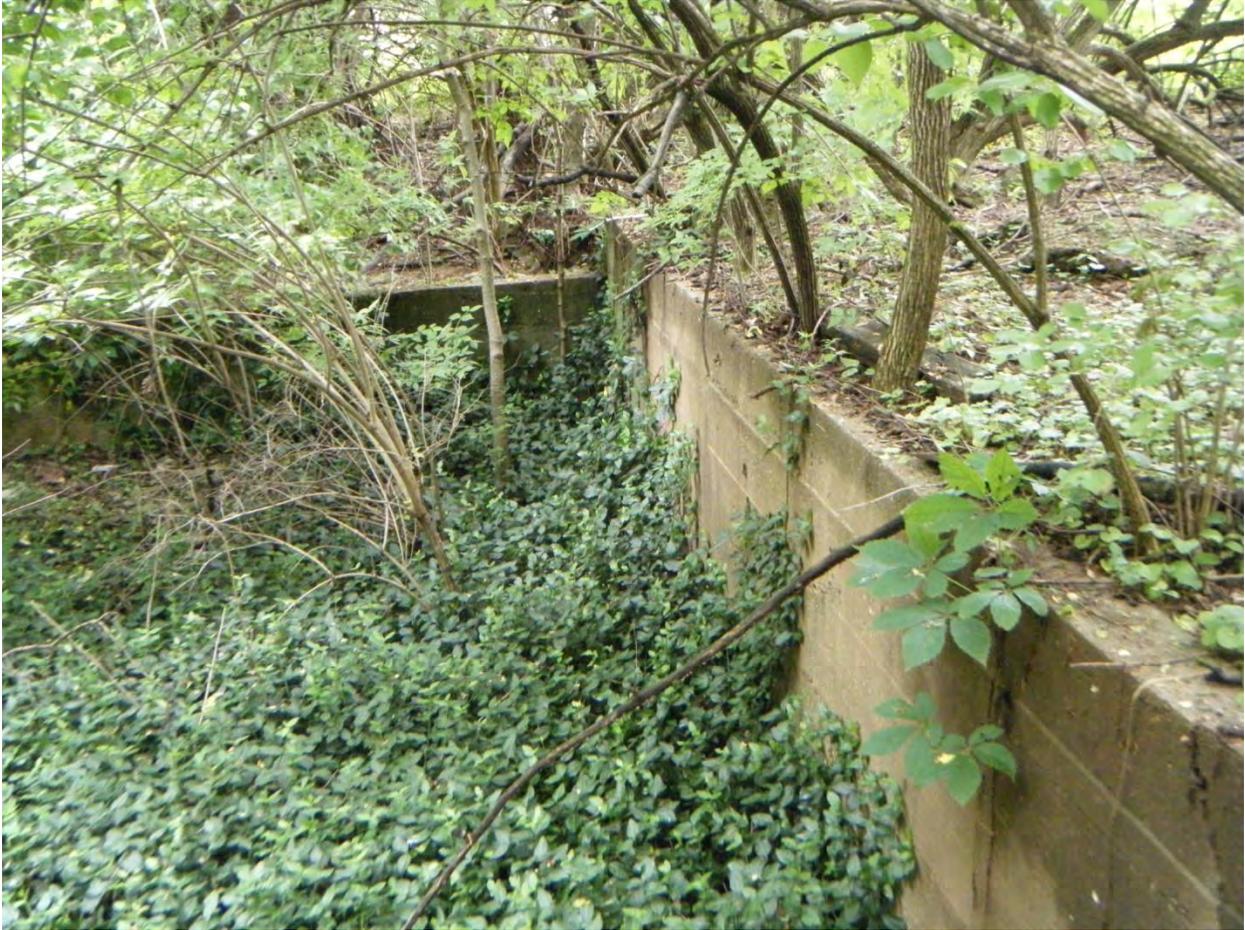
**Figure 90. Structural foundation, facing west.**

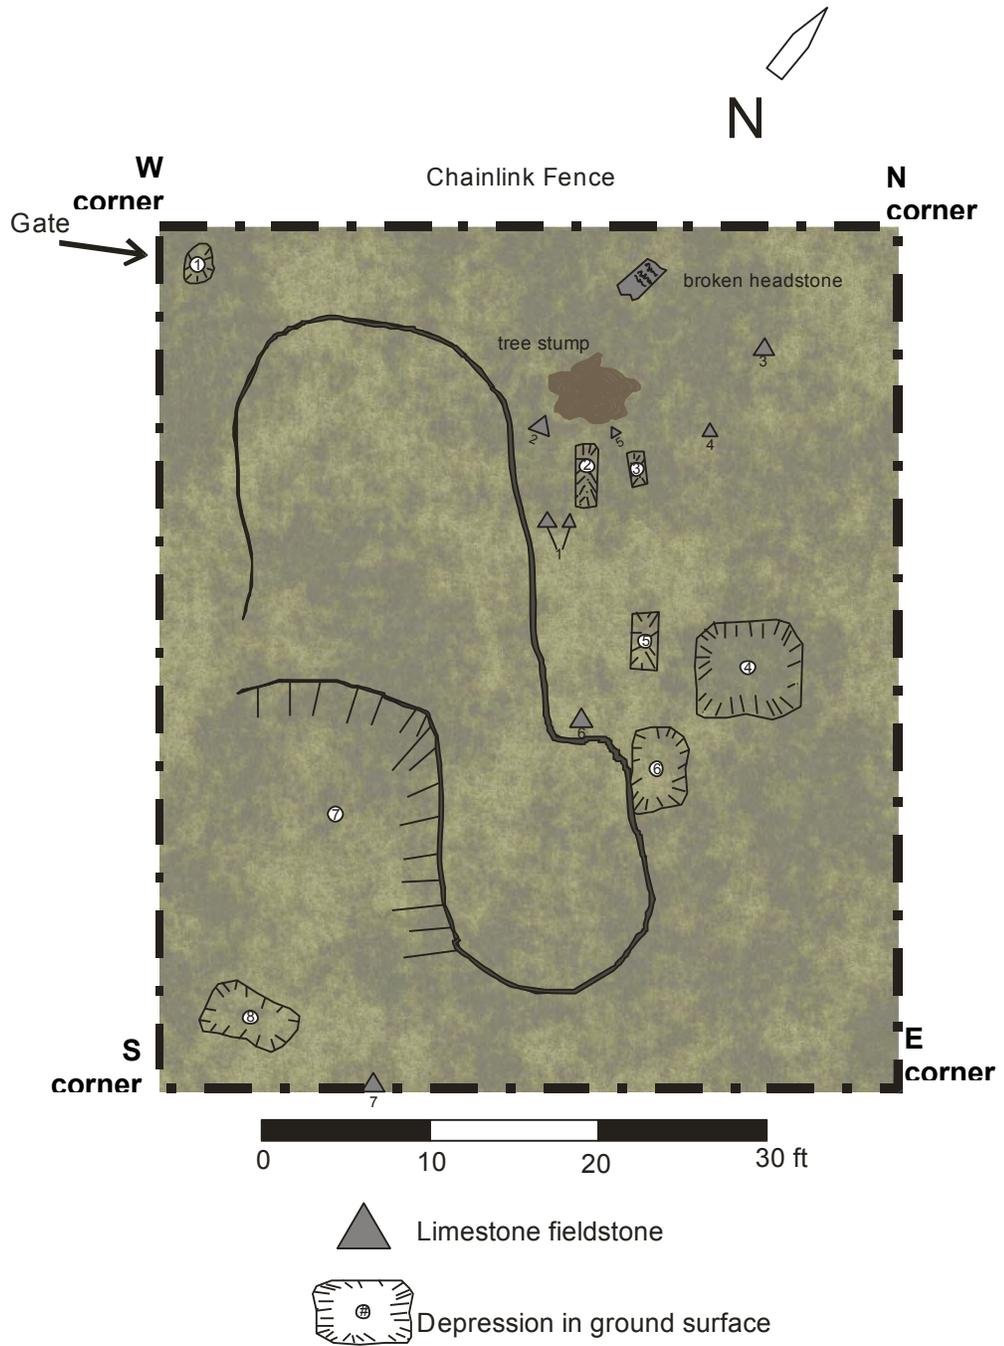
Figure 105. Plan view of Whips Cemetery.
